Vehicle Collision Experts (VECO Experts)

Post Repair Inspections and Other Repair Issues

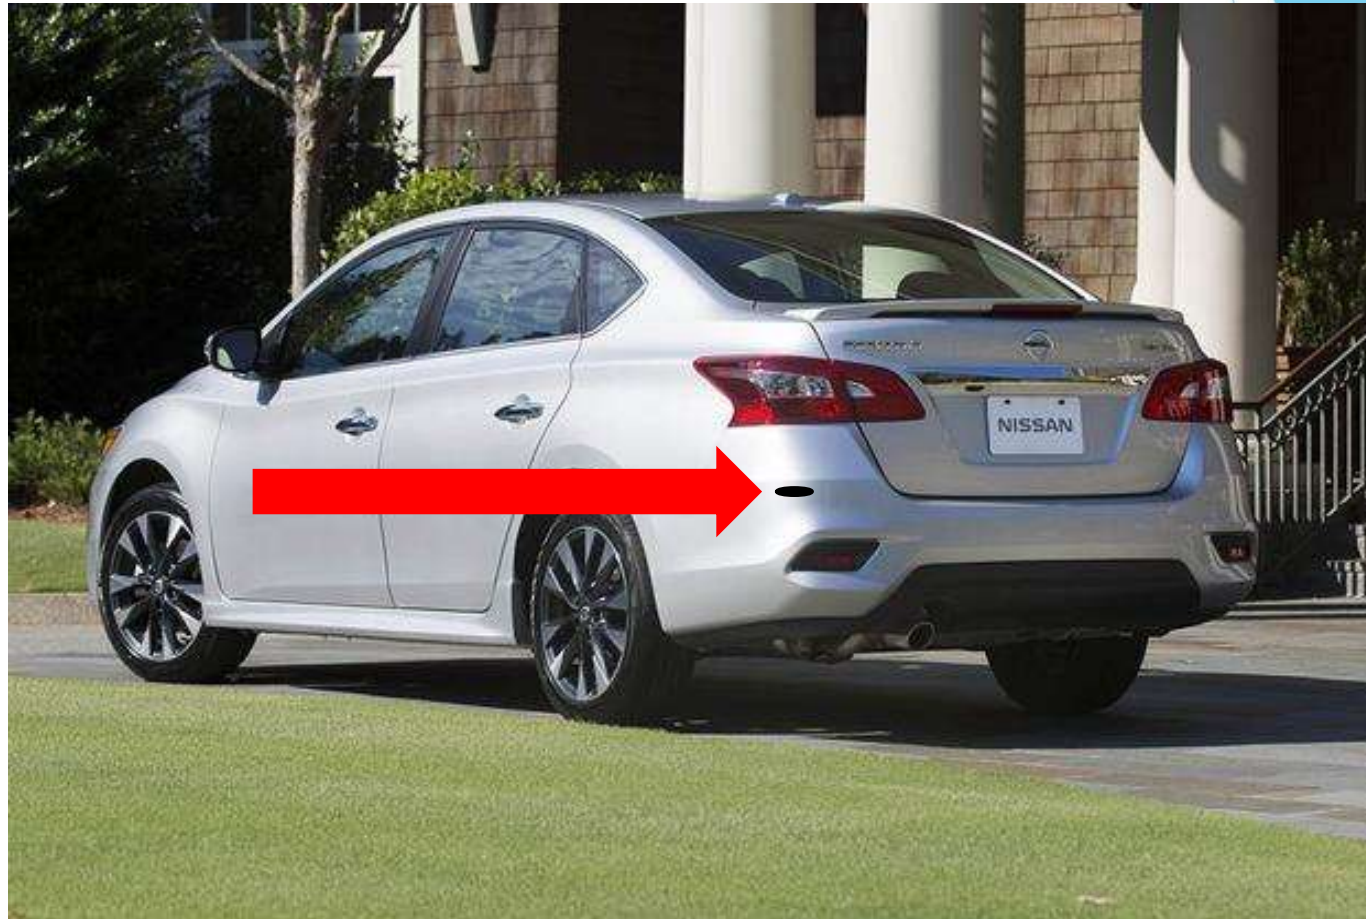
Proper OEM Repairs - Required

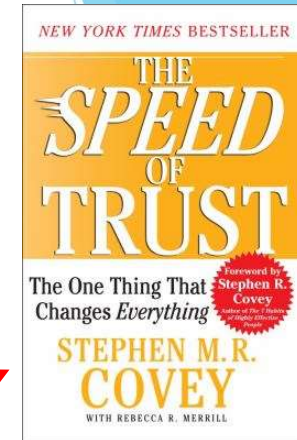
What They Look For - (Anything)

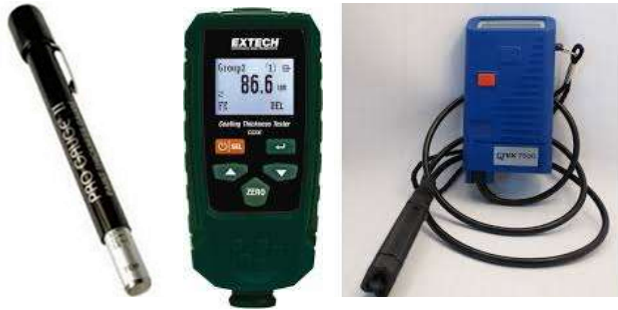
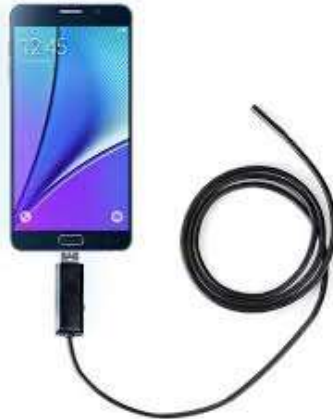
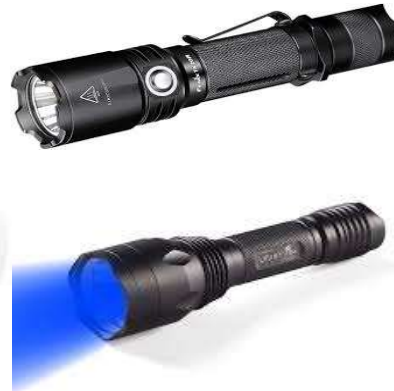
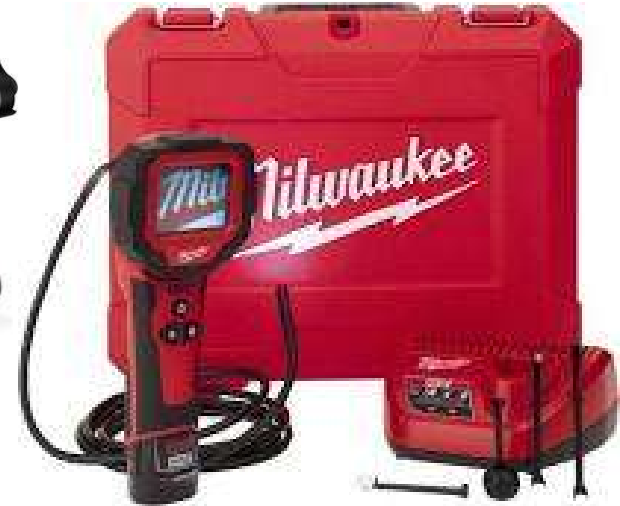
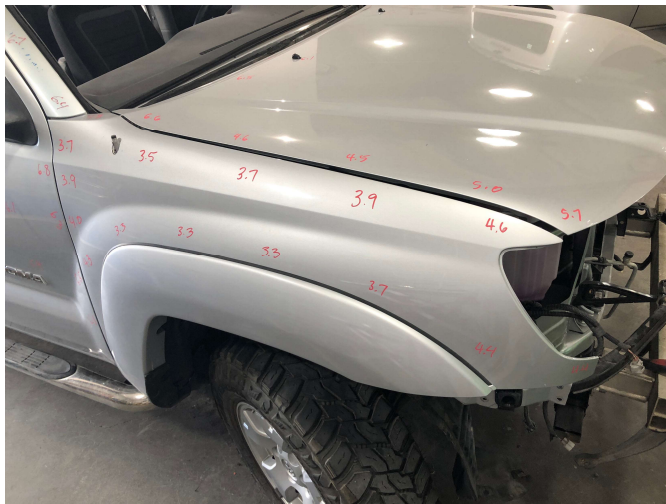
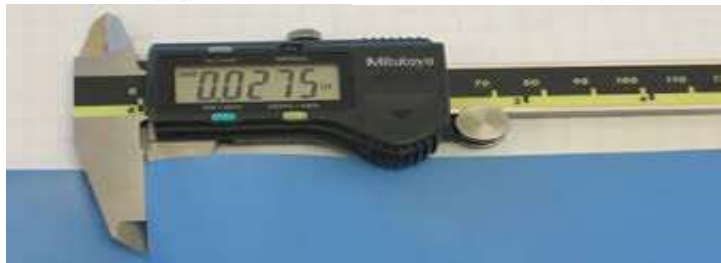
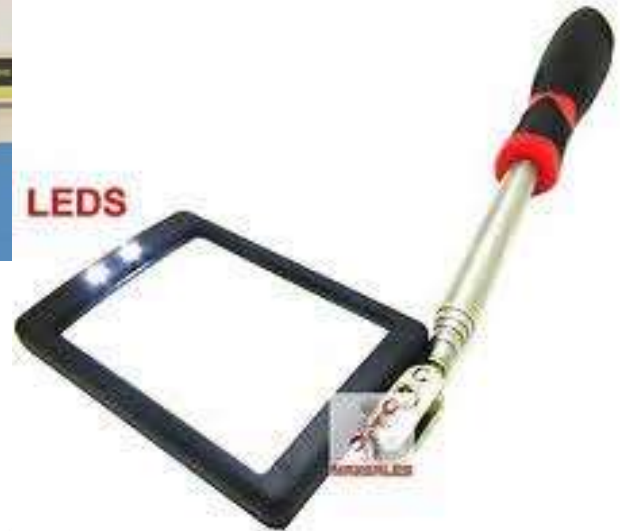
Copyright © 2018 by Vehicle Collision Experts LLC, all Right reserved.

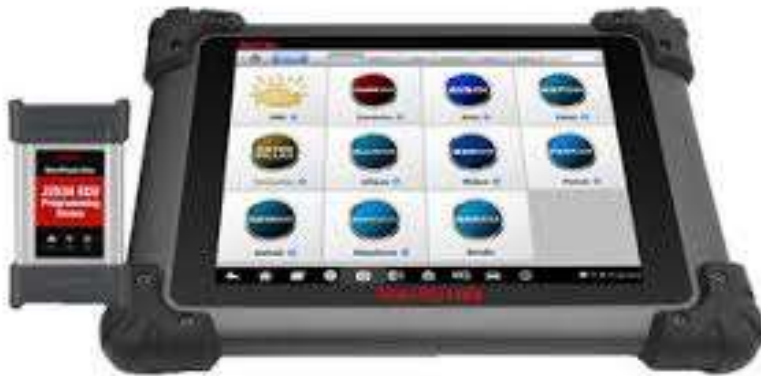
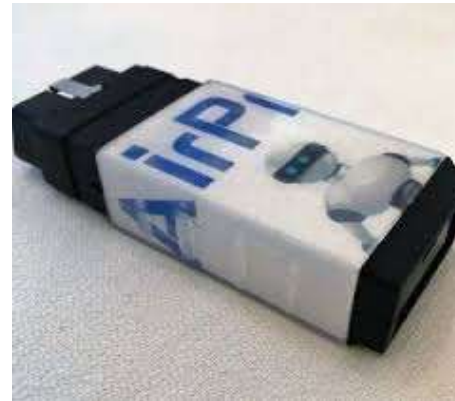
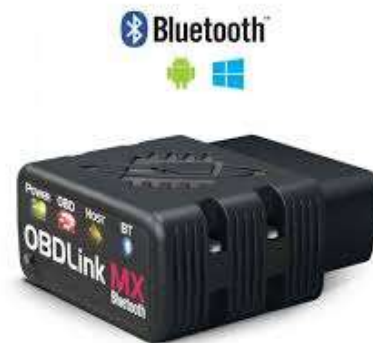
And About the File (Bullet Proof File)

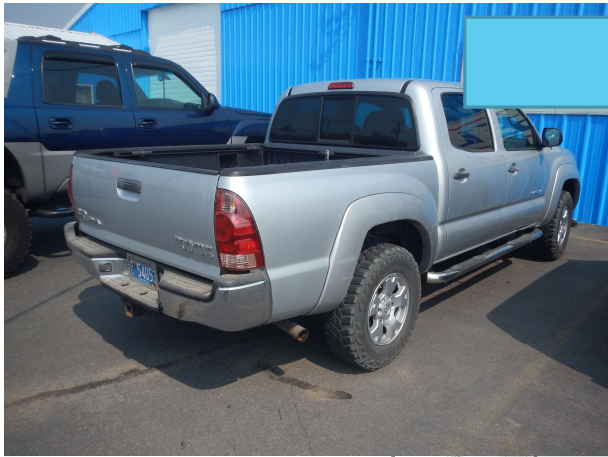
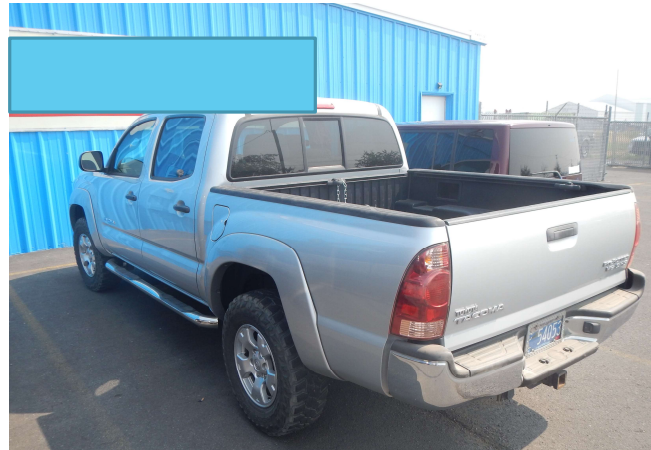
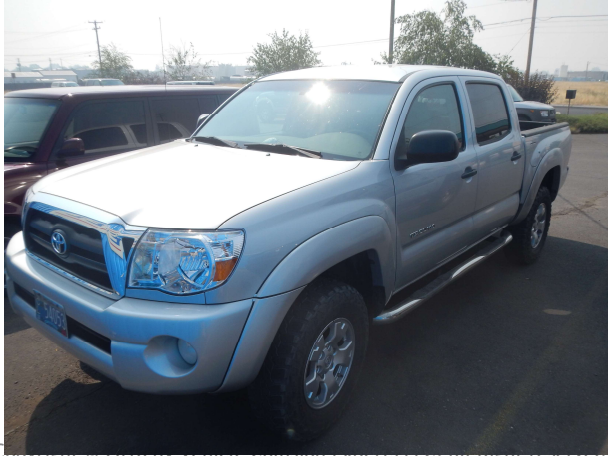
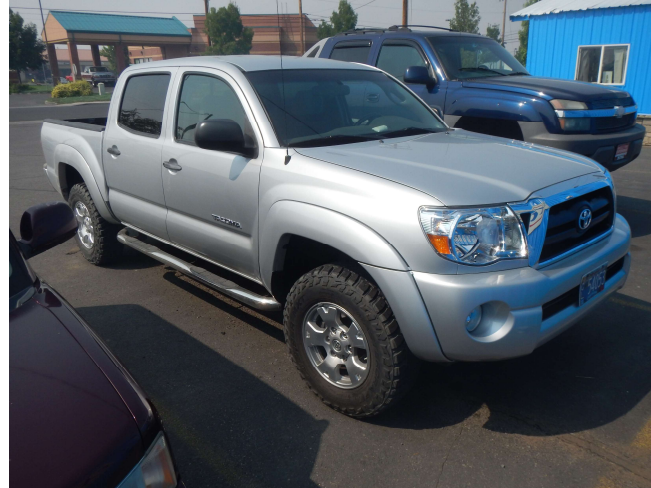
Copyright © 2016 by Remick-Garrison Experts LLC, all rights reserved.

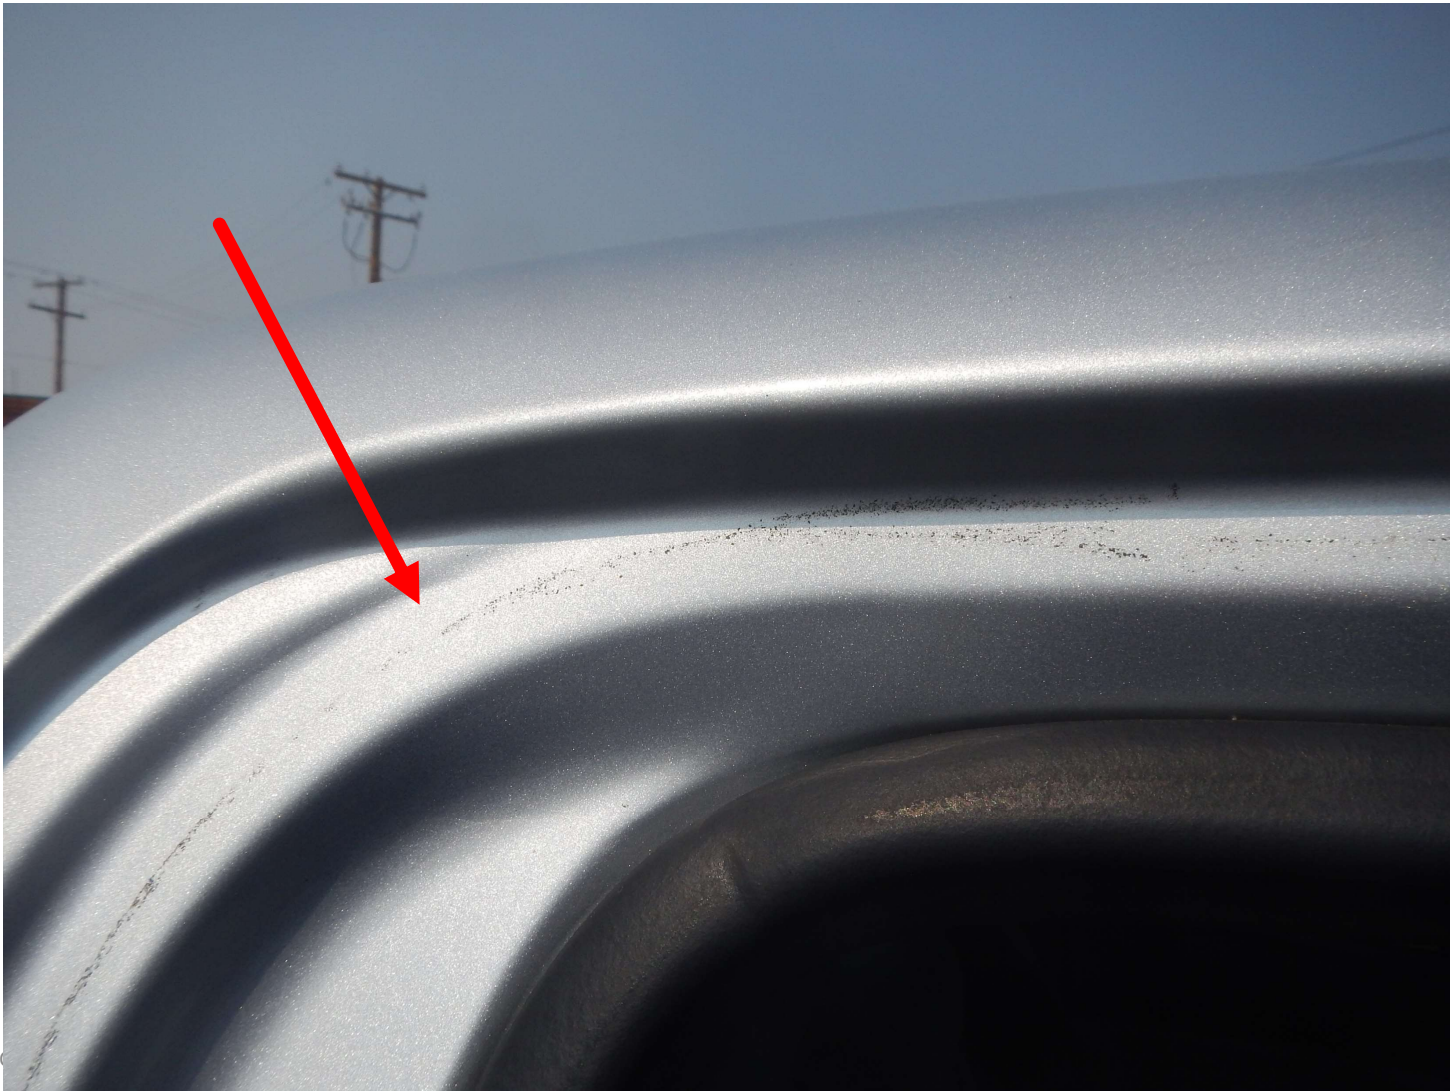
Original shop DRP Estimate: \$4150.81

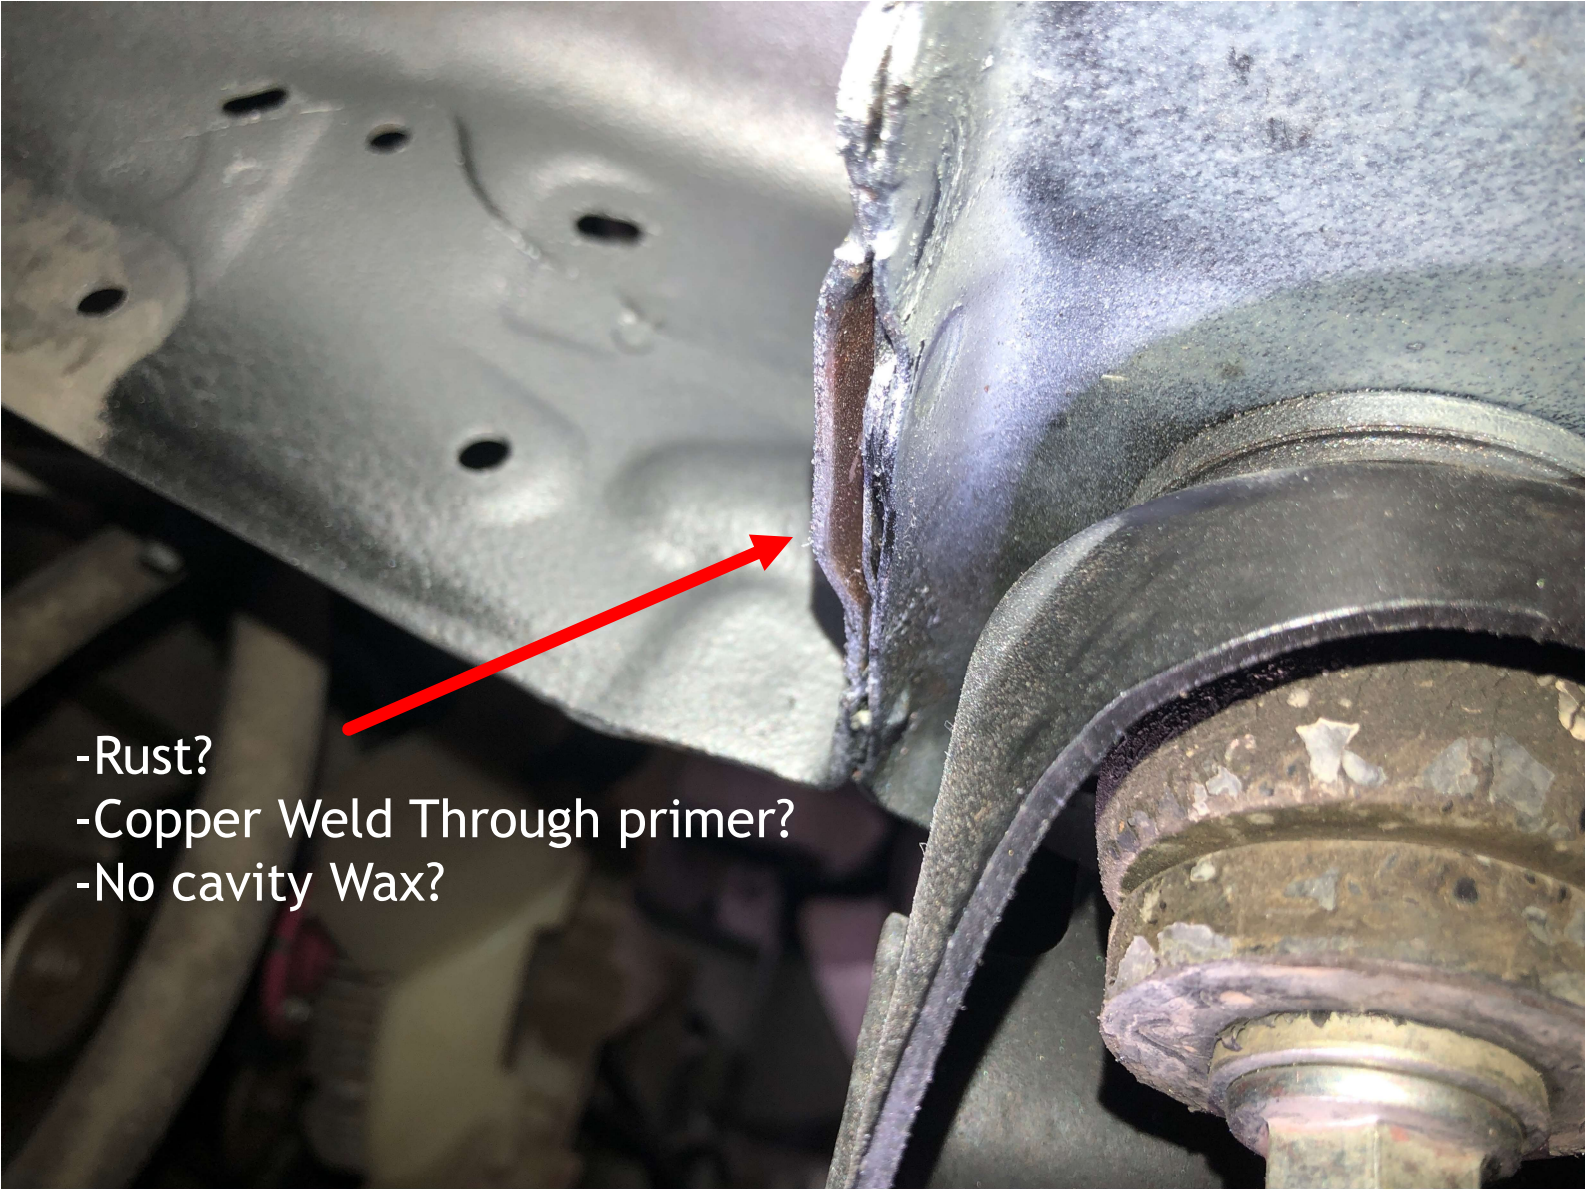
- Rust?
- Copper Weld Through primer?
- No cavity Wax?

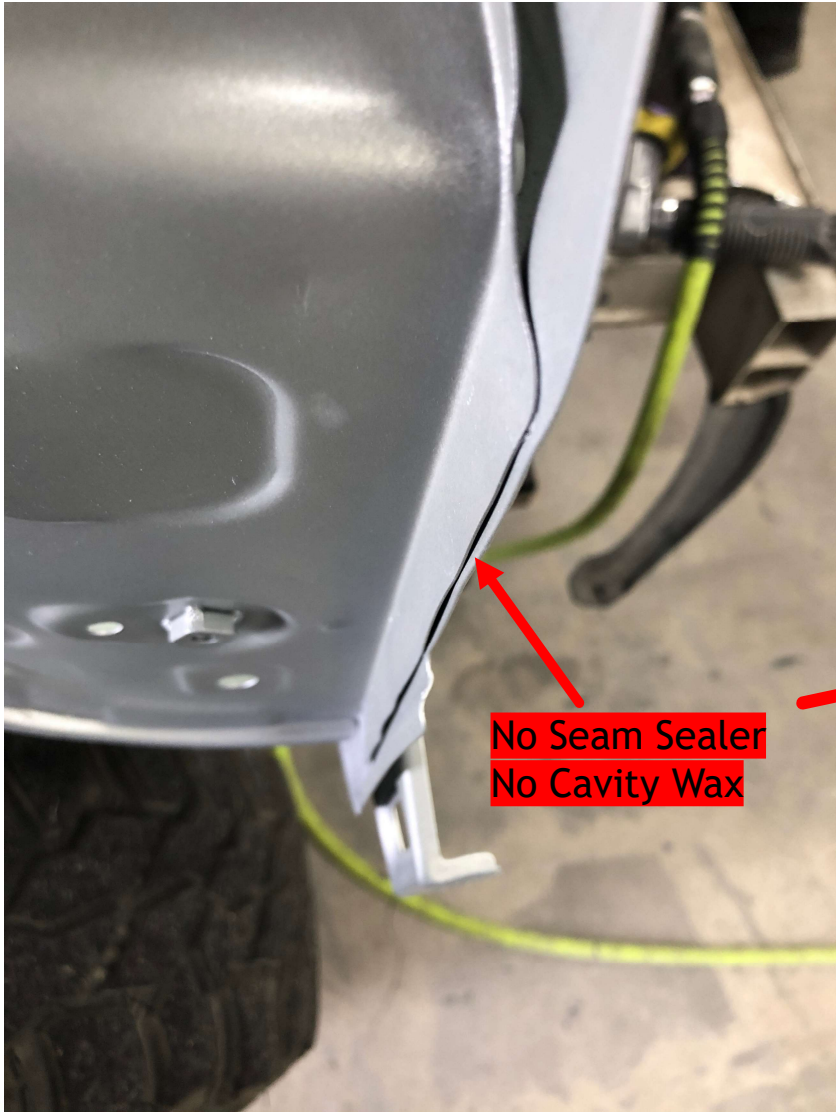
No Seam Sealer
No Cavity Wax

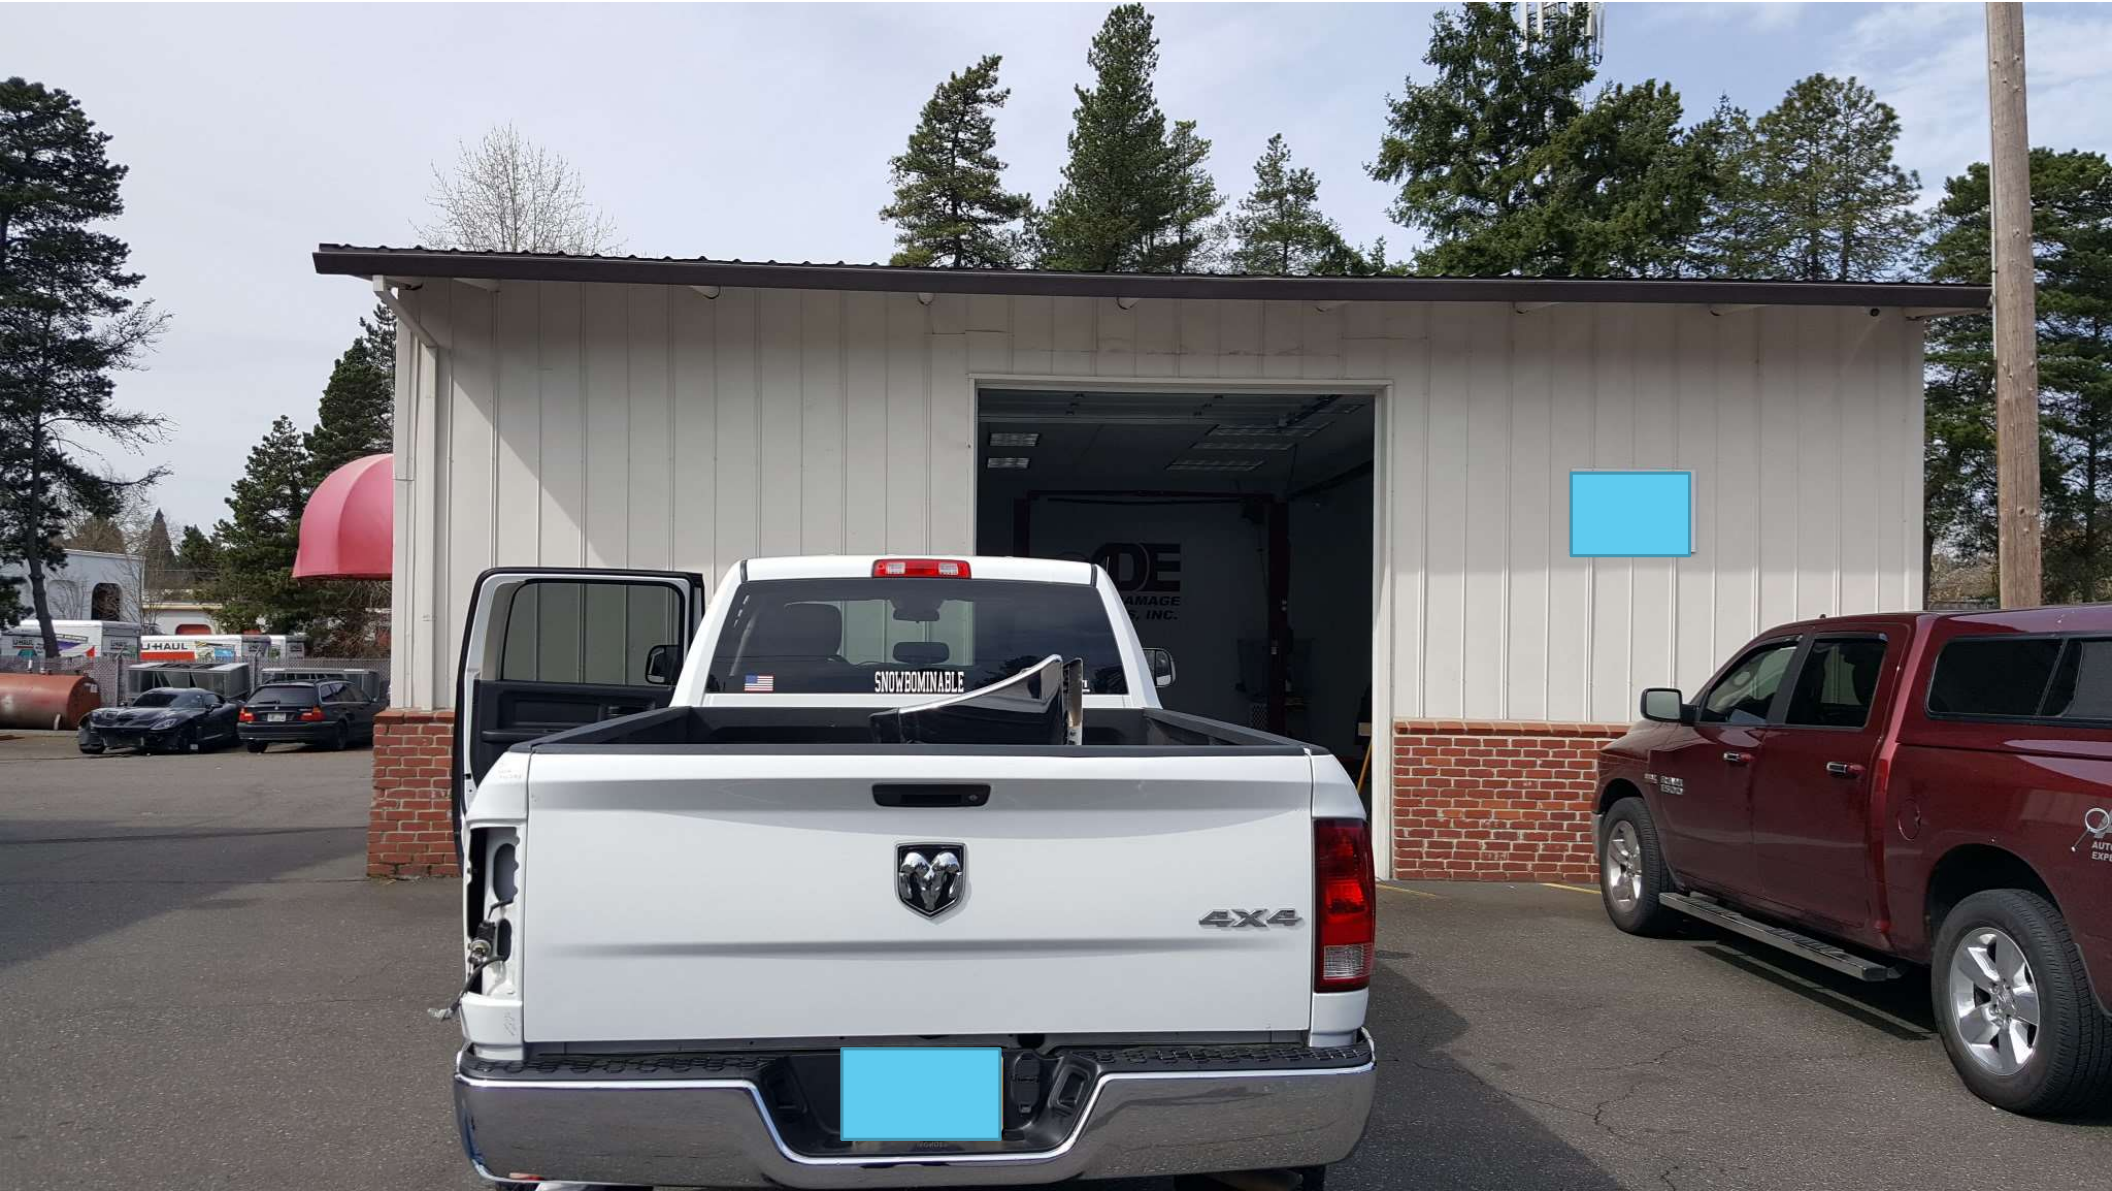
- Vehicle damaged and towed to shop
- Shop repaired vehicle
- Owner complained of a vibration at about 50
- Sent tires out to balance
- Vibration still present
- Sent to another shop, shop pulled frame and said it was done
- Vibration still present
- Sent to another shop - inspected shop did some minor repairs
- Vibration still present
- Sent to another shop - shop inspected and refused to do any repairs
- Vehicle owner hires atty and invokes appraisal clause hires appraiser
- Insurance company hires me.

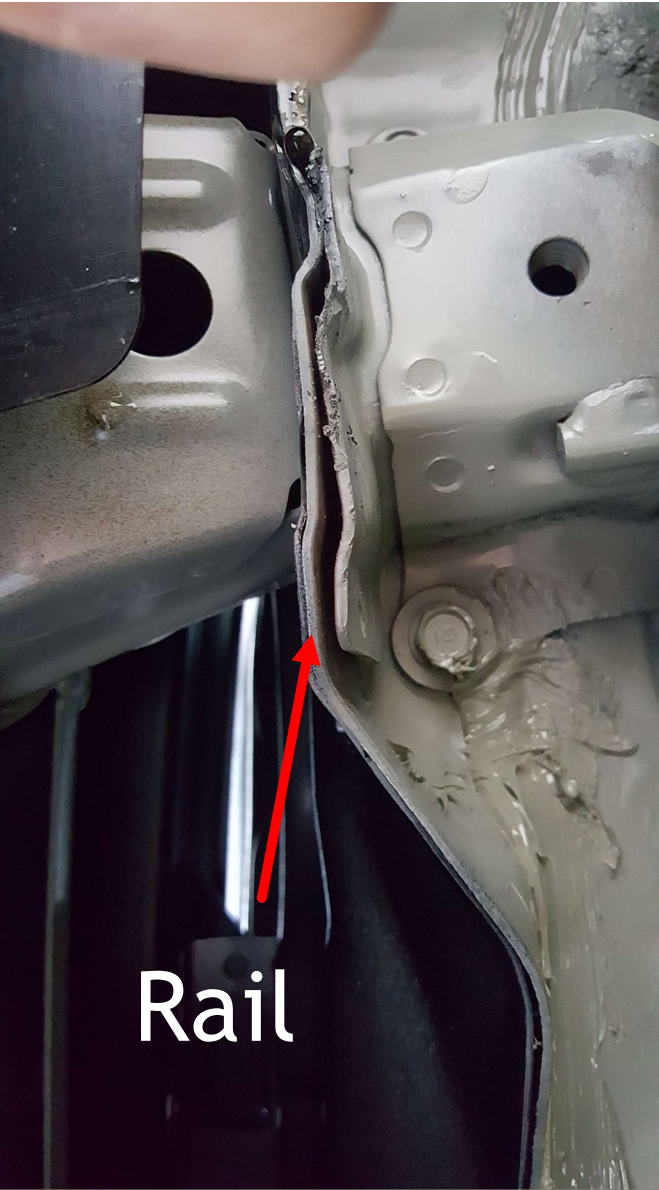
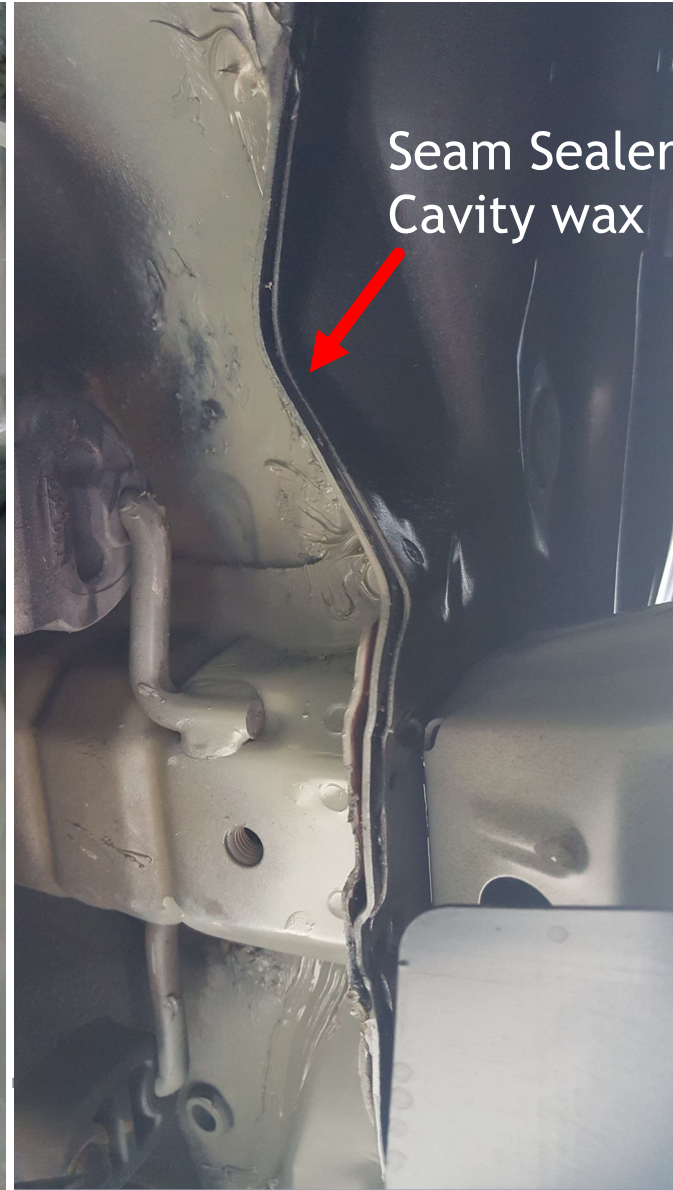
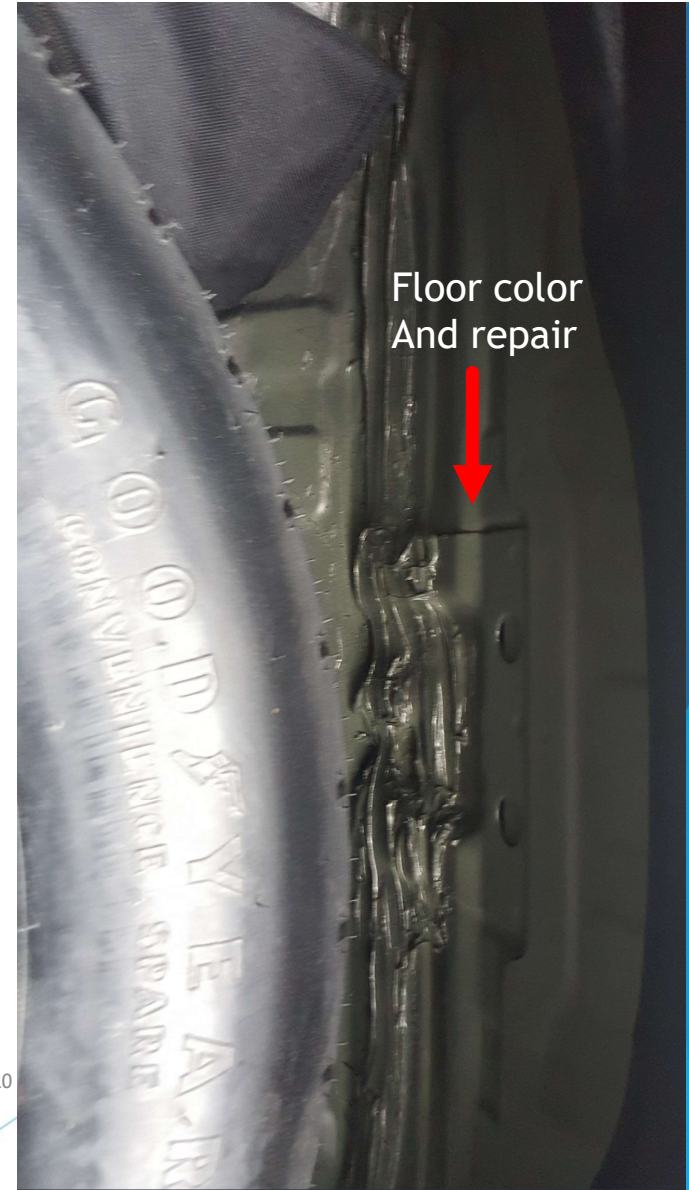
Reputable shop - said they would take care of it.

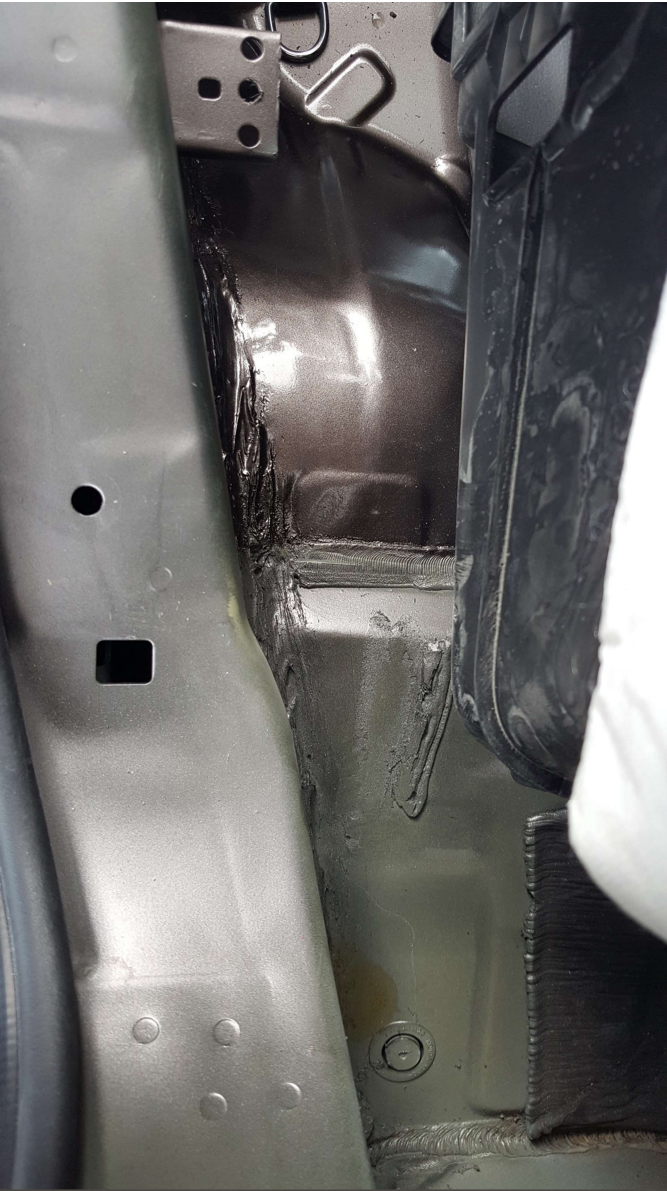
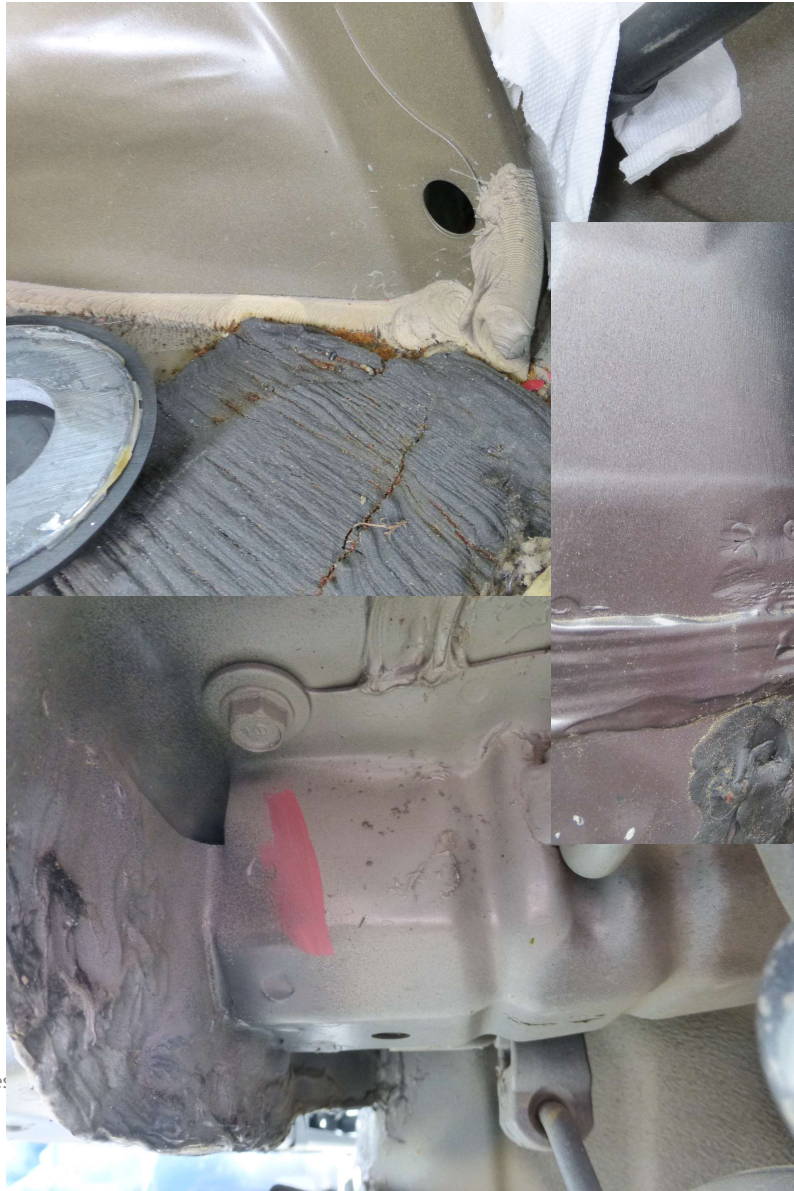
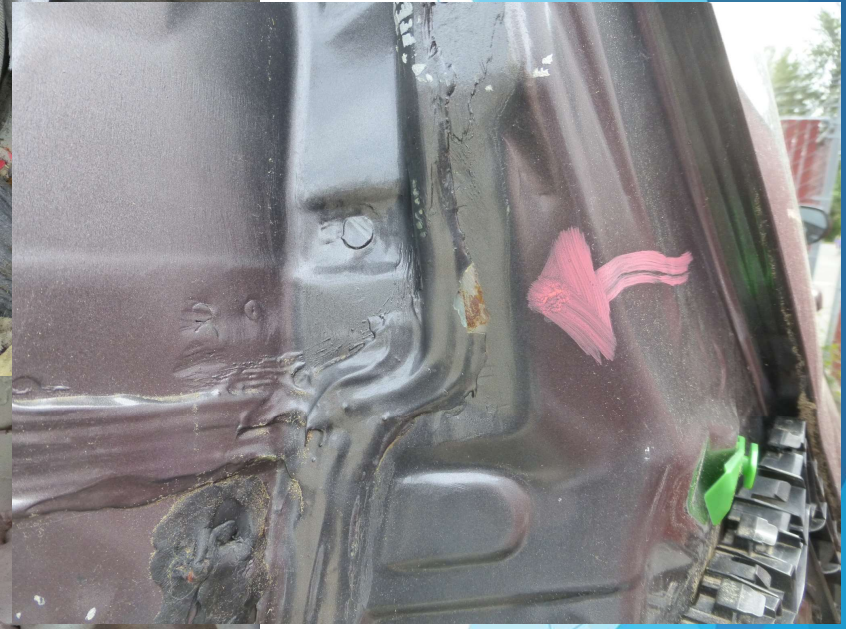
- Shop said vehicle was properly repaired now.
- Shop created a monster, customer found more stuff
- Shop did a re-repair
- Customer found more stuff
- Shop did re-repair.
- Customer gave up and started bad mouthing shop on Google, Yelp Etc....
- Rains came and customer noticed trunk was full of water.
- Taken to a water leak shop and taken apart
- Seam sealer leaking - water in between seams - complete structural re-repair.

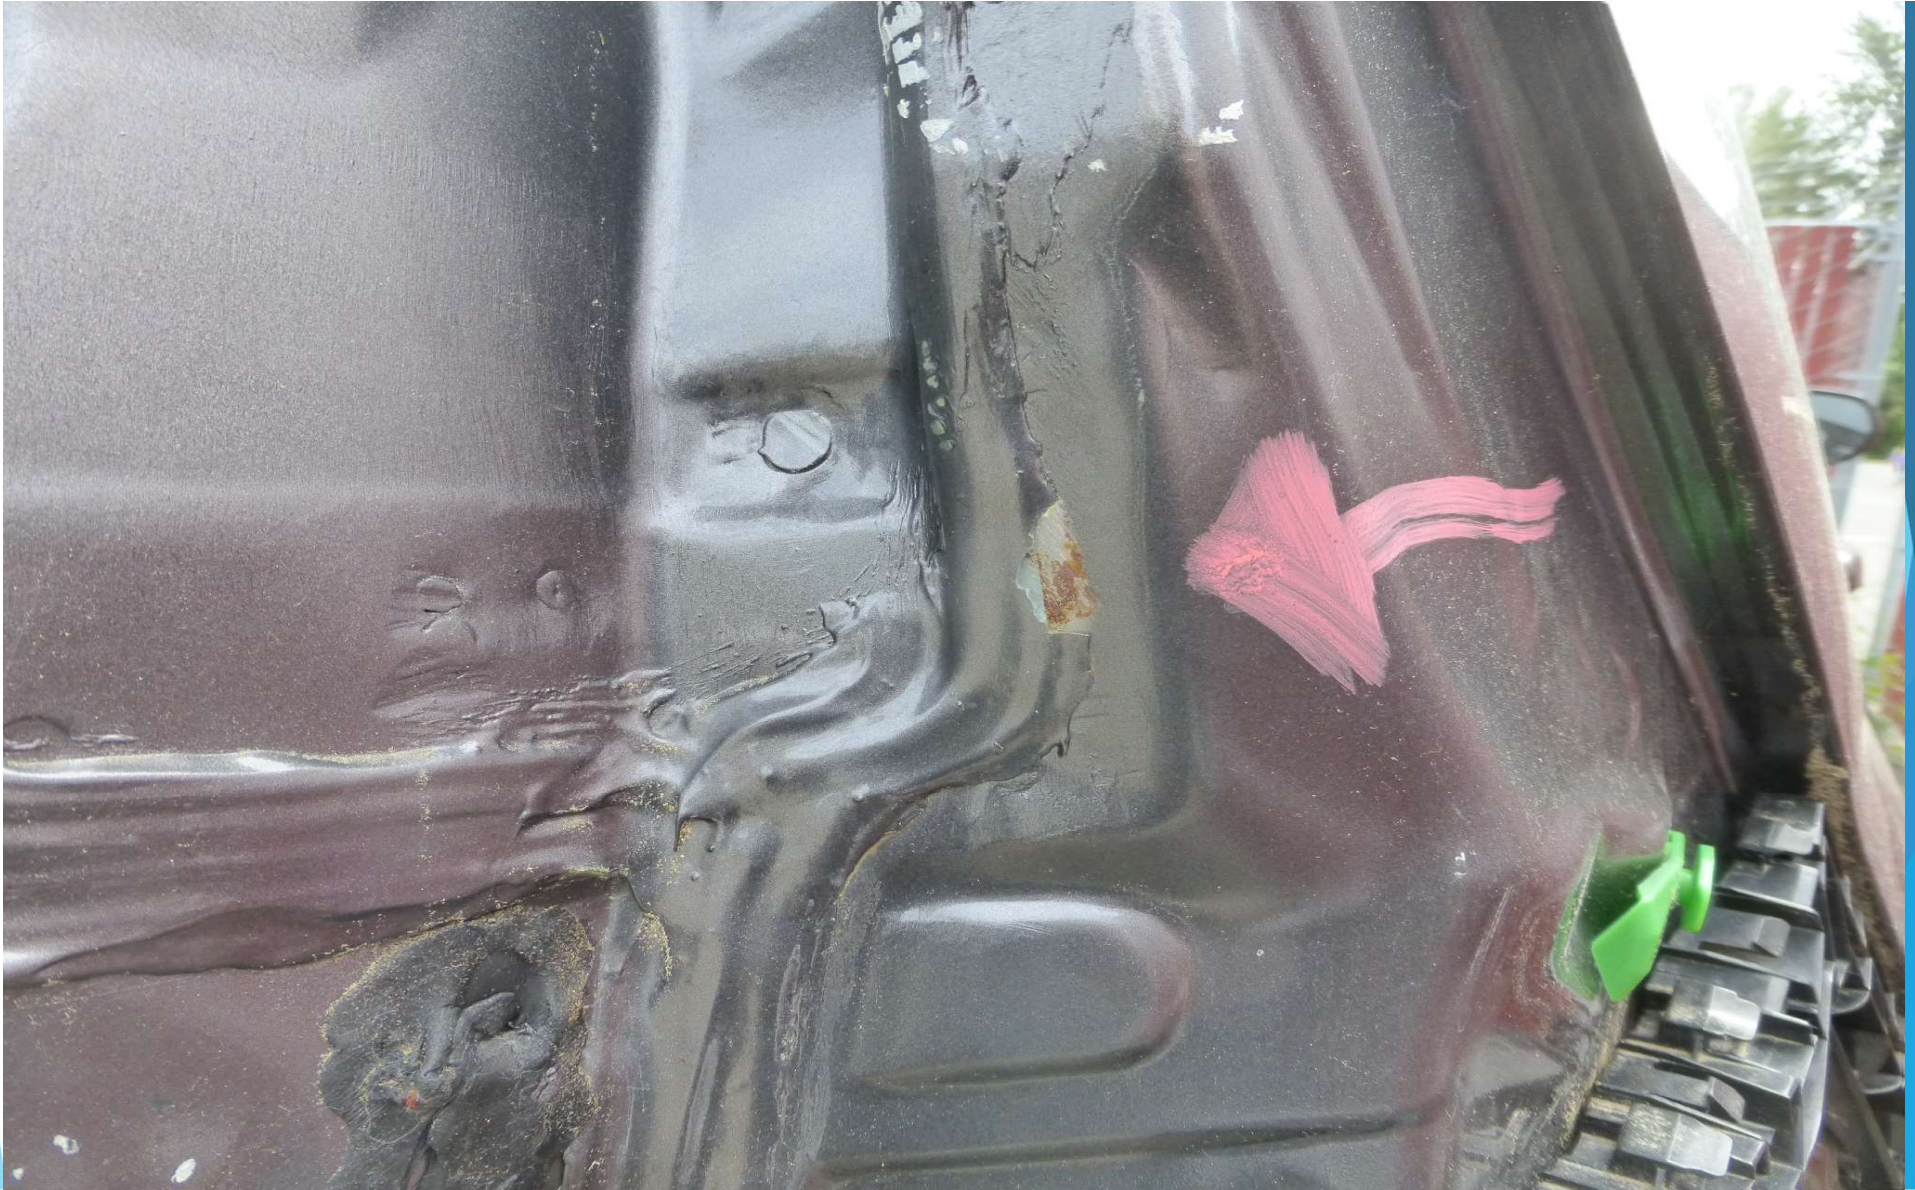
Resolution (not complete yet)

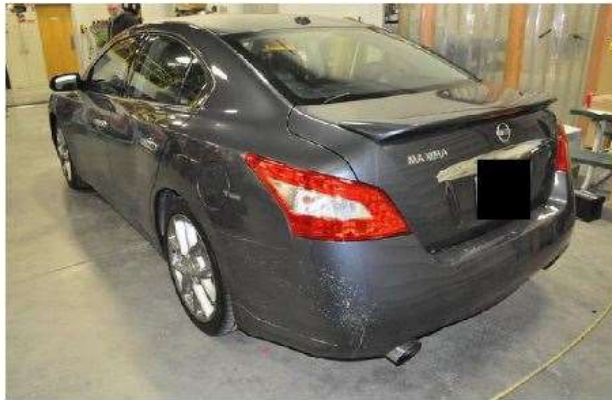
Ohio auto body shop loses appeal of attorney fees, DV over incorrectly repaired Nissan Maxima

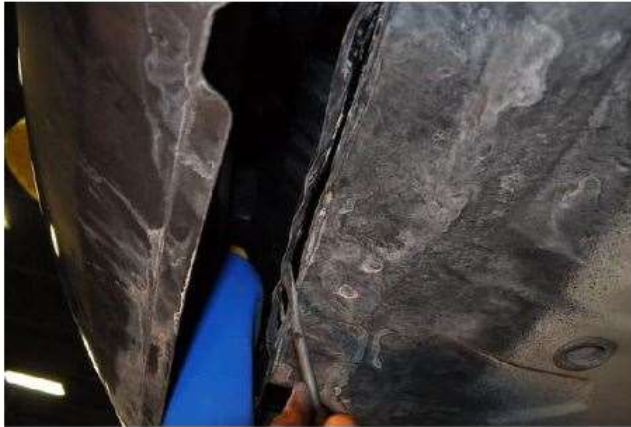
2016 Ohio Maxima outcome shows risk of rejecting OEM auto body repair procedures

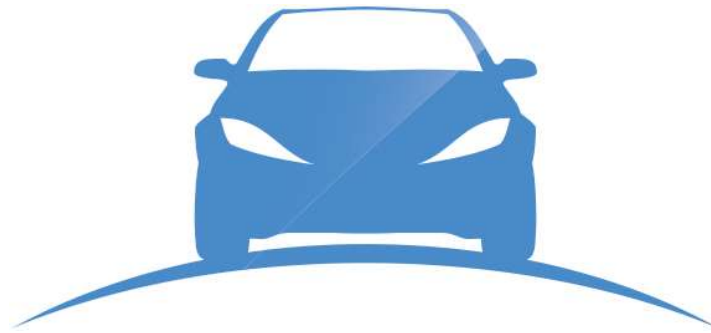
Post Repair Inspections and Other Repair Issues
